NAME AND SHA NO.: 13041 LOCATION Road Name and Number: MD 176 over Deep Run X vicinity City/Town: Dorsey Howard County: Ownership: X State County Municipal Other Bridge projects over: _ Road _ Railway X Water _ Land Is bridge located within designated district?: _ yes X no ___ NR listed district __ NR determined eligible district __ locally designated __ other Name of District _ **BRIDGE TYPE** Timber Bridge __ Beam Bridge __ Truss-Covered __ Trestle __ Timber-and-Concrete __ Stone Arch Bridge Metal Truss Bridge Moveable Bridge __ Swing __ Bascule Single Leaf __ Bascule Multiple Leaf _ Vertical Lift _ Retractile _ Pontoon Metal Girder __ Rolled Girder __ Rolled Girder Concrete Encased _ Plate Girder _ Plate Girder Concrete Encased __ Metal Suspension _ Metal Arch Metal Cantilever X Concrete _ Concrete Arch _ Concrete Slab X Concrete Beam _ Rigid Frame _ Other Type Name ___

MHT NO. <u>HO-650</u>

MARYLAND INVENTORY OF HISTORIC PROPERTIES HISTORIC BRIDGE INVENTORY MARYLAND STATE HIGHWAY ADMINISTRATION MARYLAND HISTORICAL TRUST

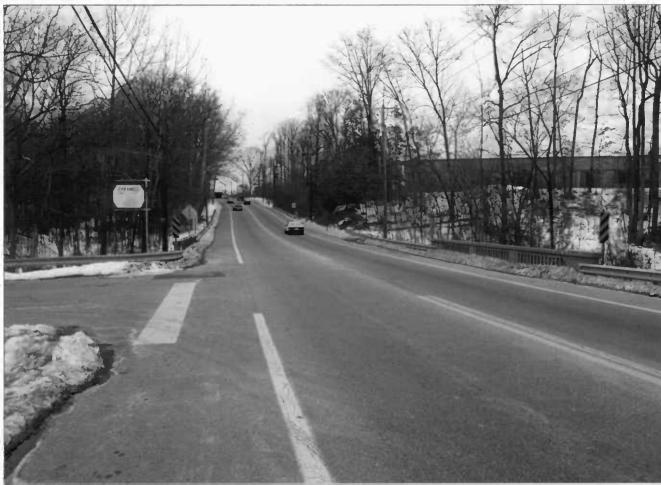
Inventory # Ho-650

Name <u>13041</u>	-MOITLOVER DEEP RUN
County/State	: HOWARD IMD
Name of Pho	otographer DAVID DIEHL
Date 2 9	5
·	
Location of	Negative SHA
Description	EAST APPROACE LOOKING
•	PORTH WEST
1	4
Number 29	of 32

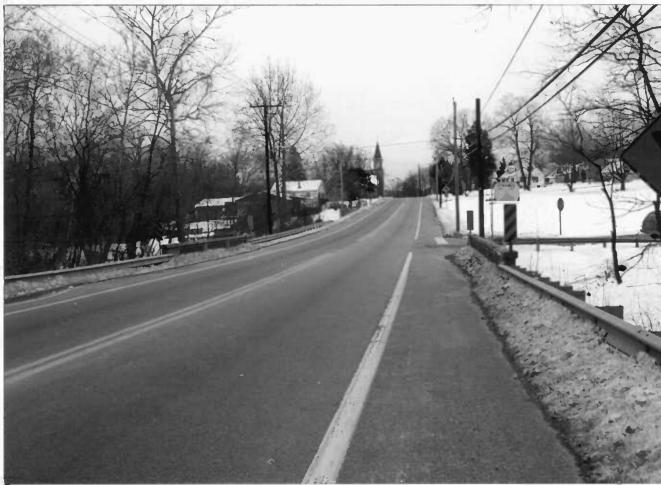
Inventory	#HO 650
•

Name 13041 - MD 1760 VER DEEP KUN
County/State Howard / mo
Name of Photographer DAVID DIEHL
Date 295
Location of Negative SHR
Description WEST APPROACH LOOKING
SOUTH EAST
2 4
Number 30 of 32

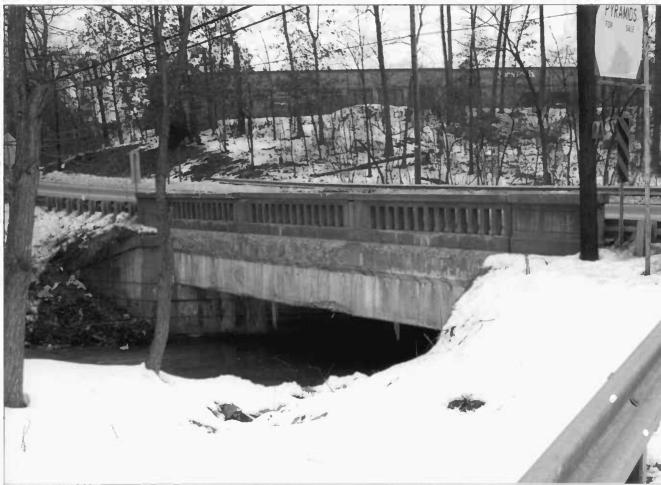
Inventory	#	40	-650
-----------	---	----	------

Photographs dated January 1995 illustrate the deteriorated condition of the structure. The southern parapet, headwall, and girders all exhibit severe spalling and disintegrating concrete. The north elevation and the substructure, however, appear to be in relatively good condition.

Name 13041-MO 176 OVER (DEEPRUN	
County/State Howard	np	
Name of Photographer DRUID	DIEHL	
Date 2 95		
Location of Negative SNA		
Description South ELEVATOR	on Looking	
NORTH		
Number $\frac{3}{100}$ Number

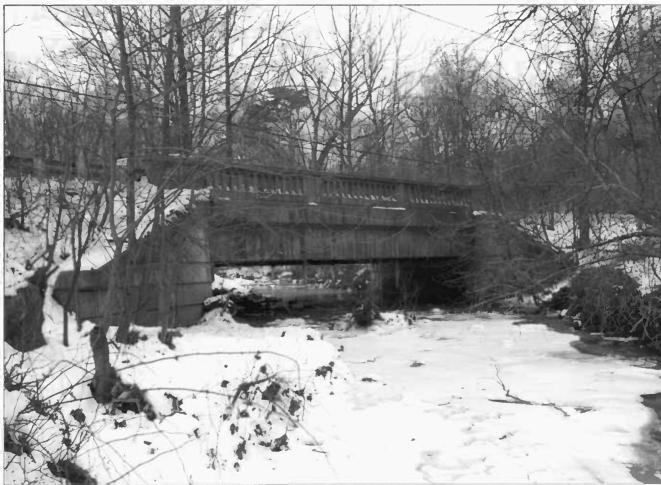
Inventory	#	Ho	,.	6	1	0
111 (011001)		-

Name 13041-MD 176 OVER DEEP RUN
County/State Howaro mo
County/state Rook to 11112
Name of Photographer DAVID DIEHL
Date 2 45
Location of Negative SHA
Description NORTH ELEVATION LOOKING SOUTH WEST
DUTH WEST
Number of 32
